New York Department of Environmental Conservation
Division of Environmental Remediation
Region 9 Office-Buffalo

FIELD INSPECTION REPORT

Site Name: Tonawanda Coke Plant Site

Purpose of Inspection: Respond to a spill complaint of the release of petroleum products from equipment and vehicles used on the property. In attendance during the inspection were Bob Kolvek and Pat Cahill representing Tonawanda Coke. Also in attendance during the inspection were Michael Hodanish and Larry D'Andrea of the EPA - Edison Office, who conducted a SPCC inspection of the facility.

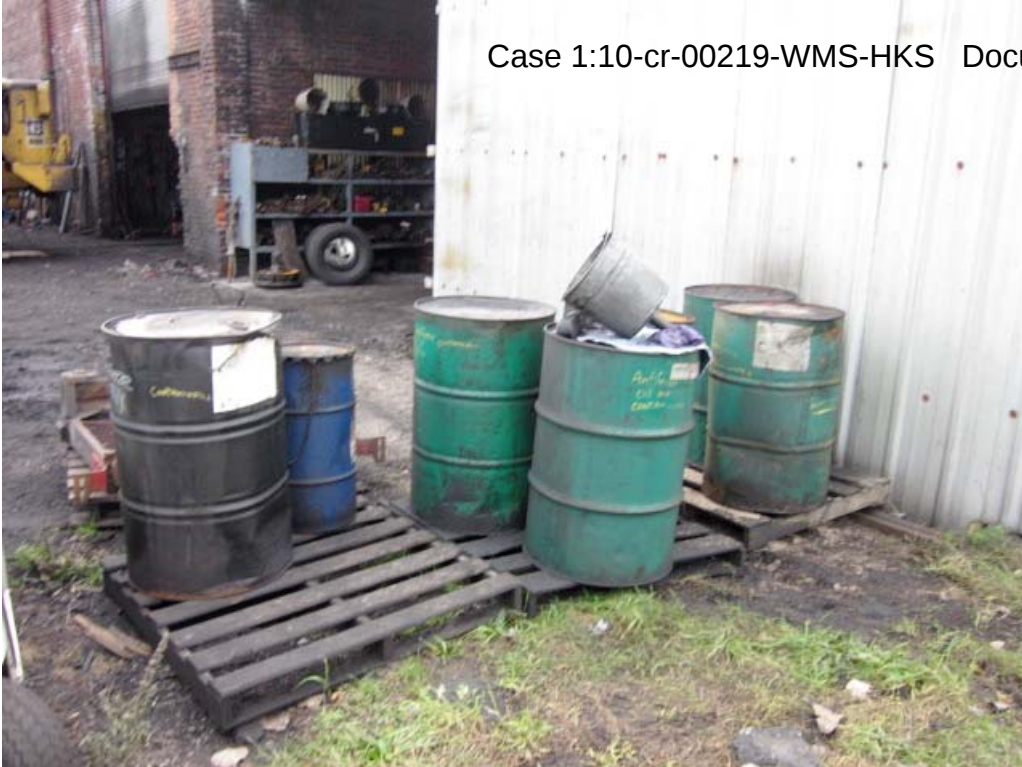
image.sp1207205.2012-11-14.10-OilHouseDrums.jpg

Observation: No totes were observed in the area of the oil house/round house during the inspection. 6 drums of "antifreeze/waste oil" were observed on the north side of the roundhouse on pallets. TCC staff indicated these drums are periodically picked up by SafetyKleen for disposal. The area of the empty drums was not inspected at this time (image.sp1207205.2012-11-14.10-OilHouseDrums.jpg).

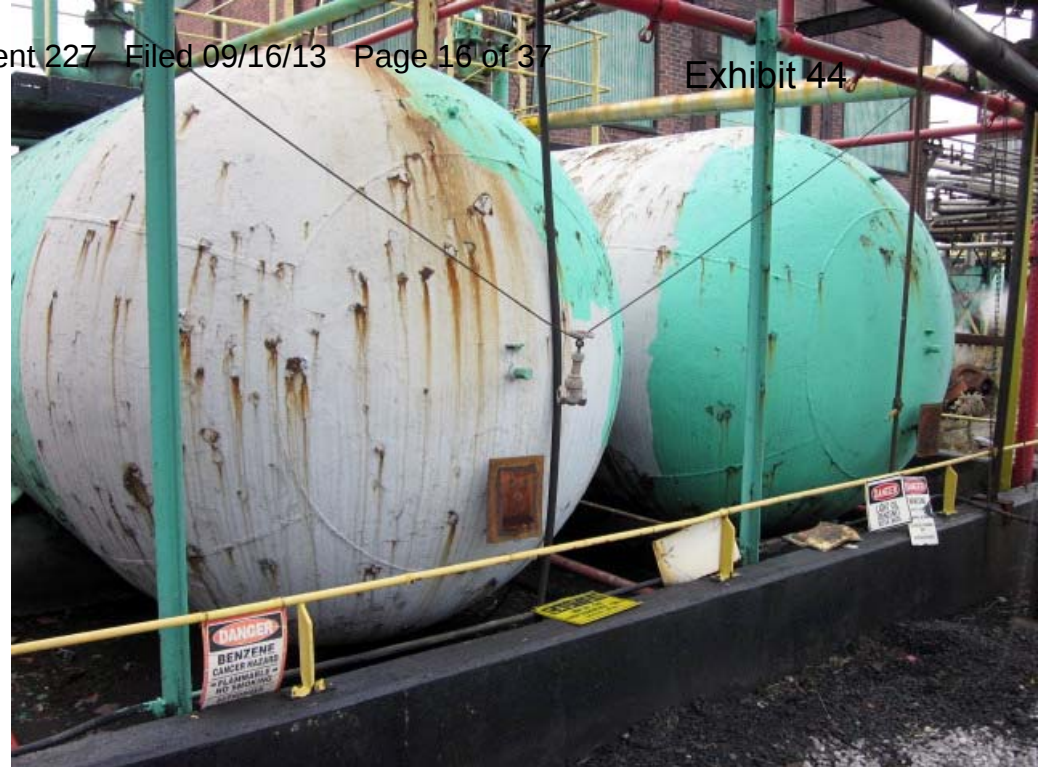
image.sp1207205.2012-11-14.11-LightBenzeneOilTanks.jpg

Also observed was a historical stained area, event of a past spill, in the area of the Light Benzene Oil storage tank area (image.sp1207205.2012-11-14.11-LightBenzeneOilTanks.jpg). This spill was also outside of the tanks containment structure (image.sp1207205.2012-11-14.11-LightBenzeneOilTankStaining.jpg).

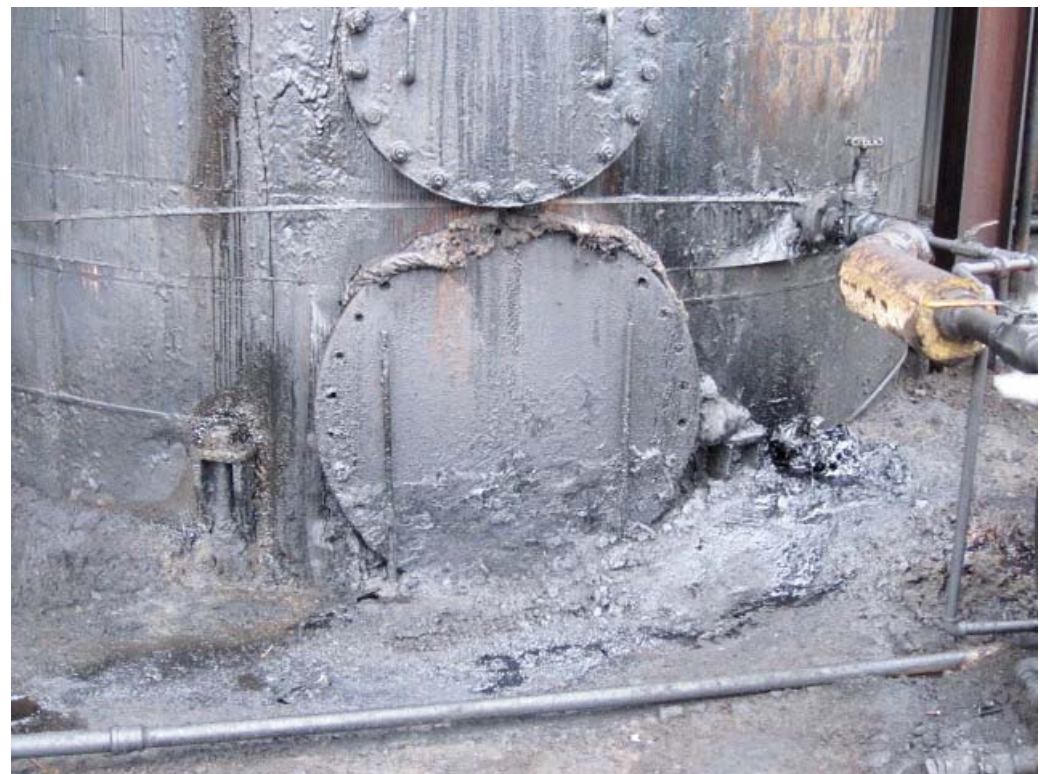
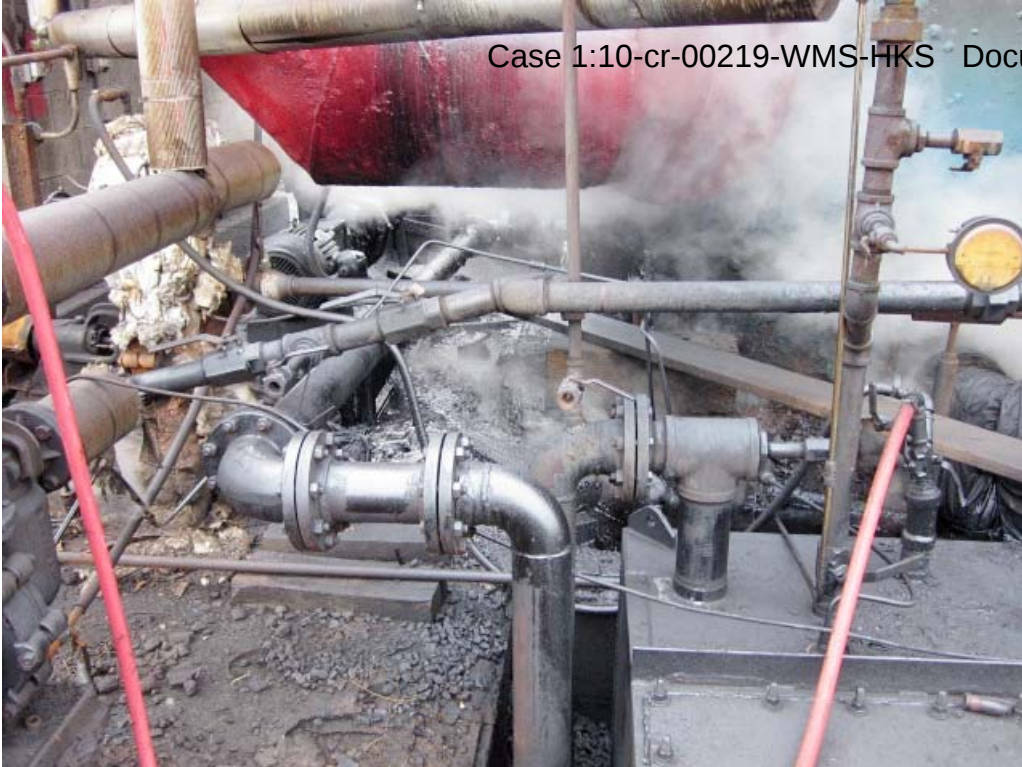
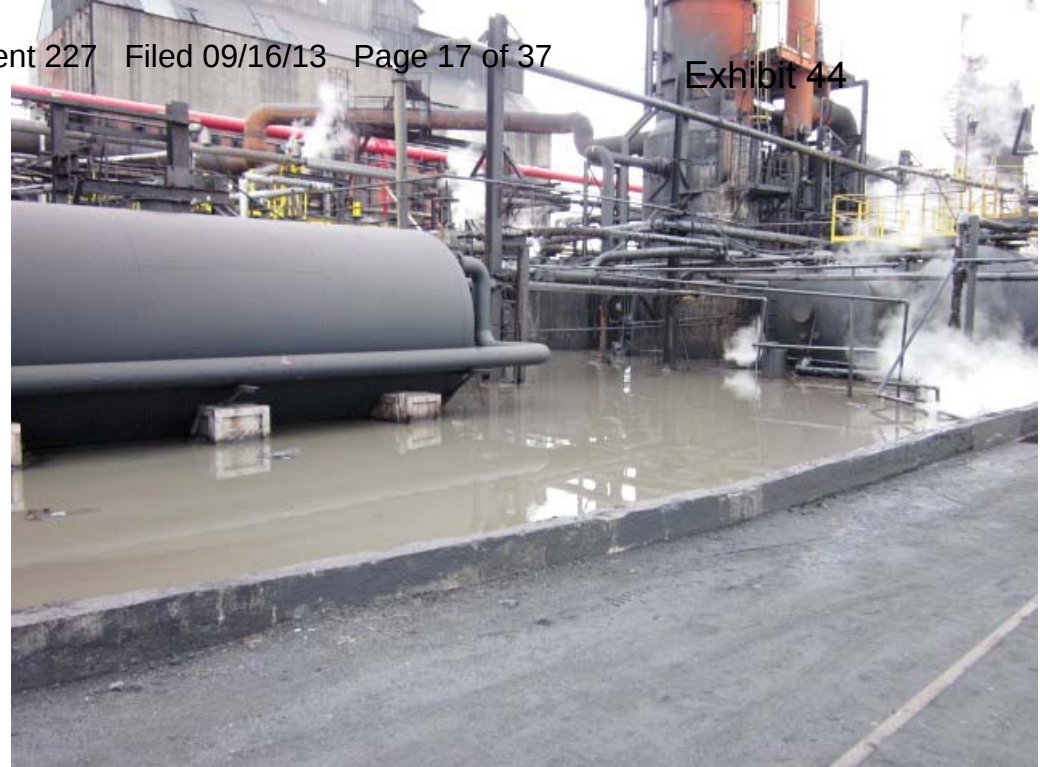
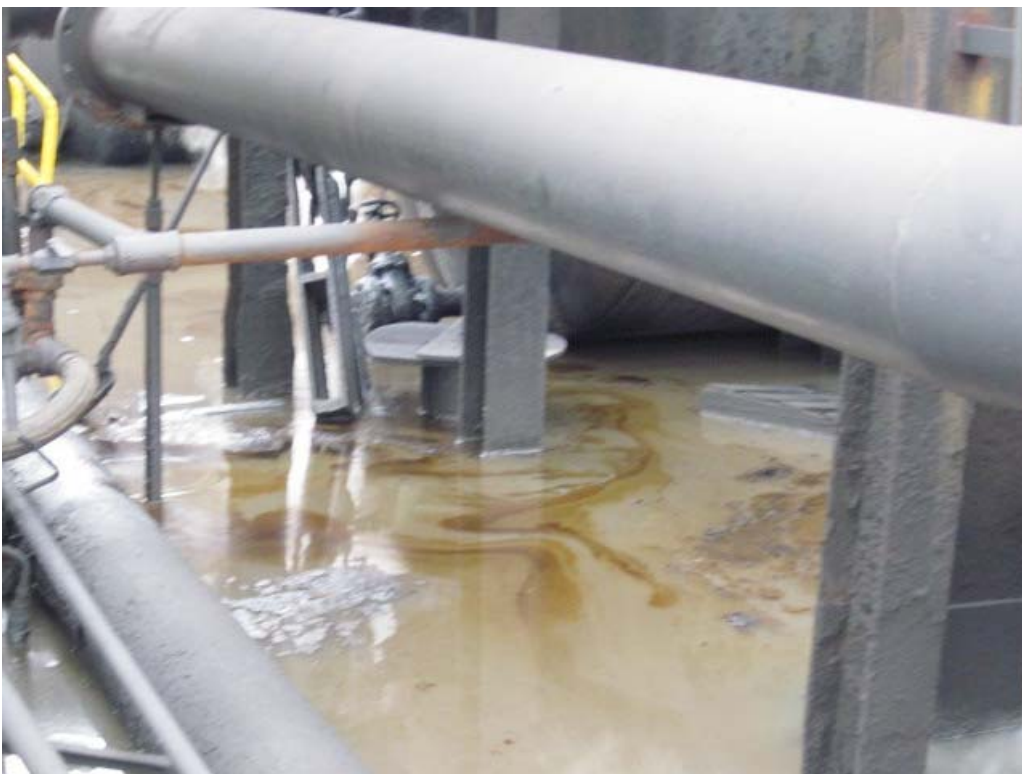
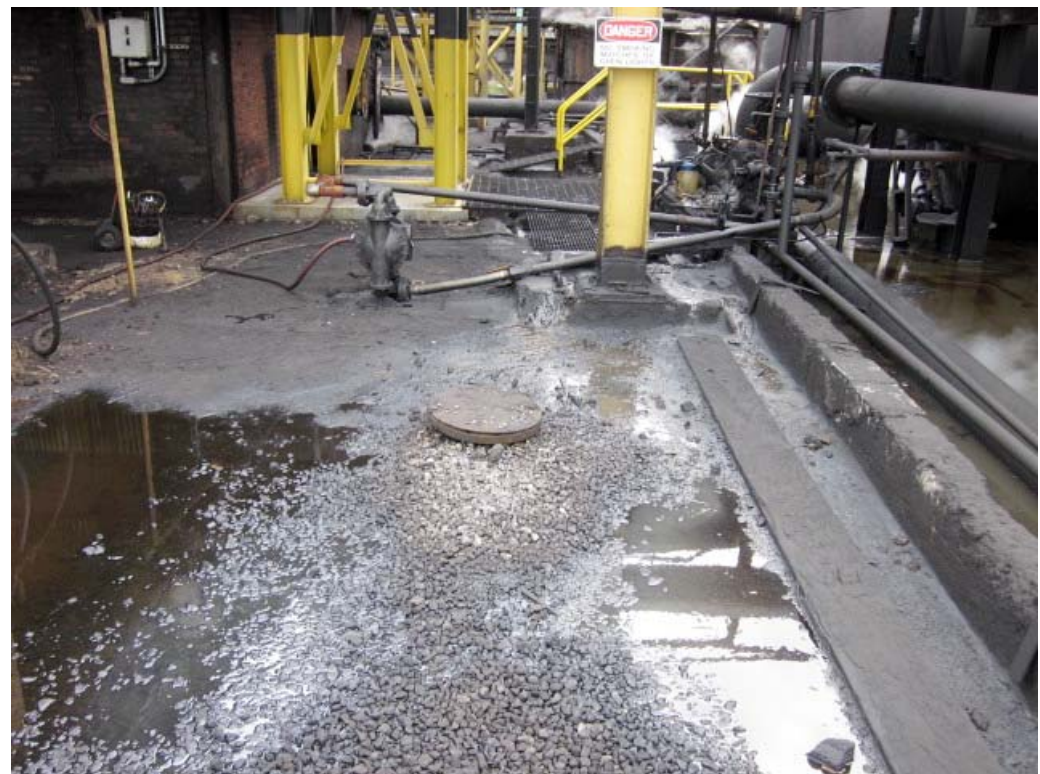
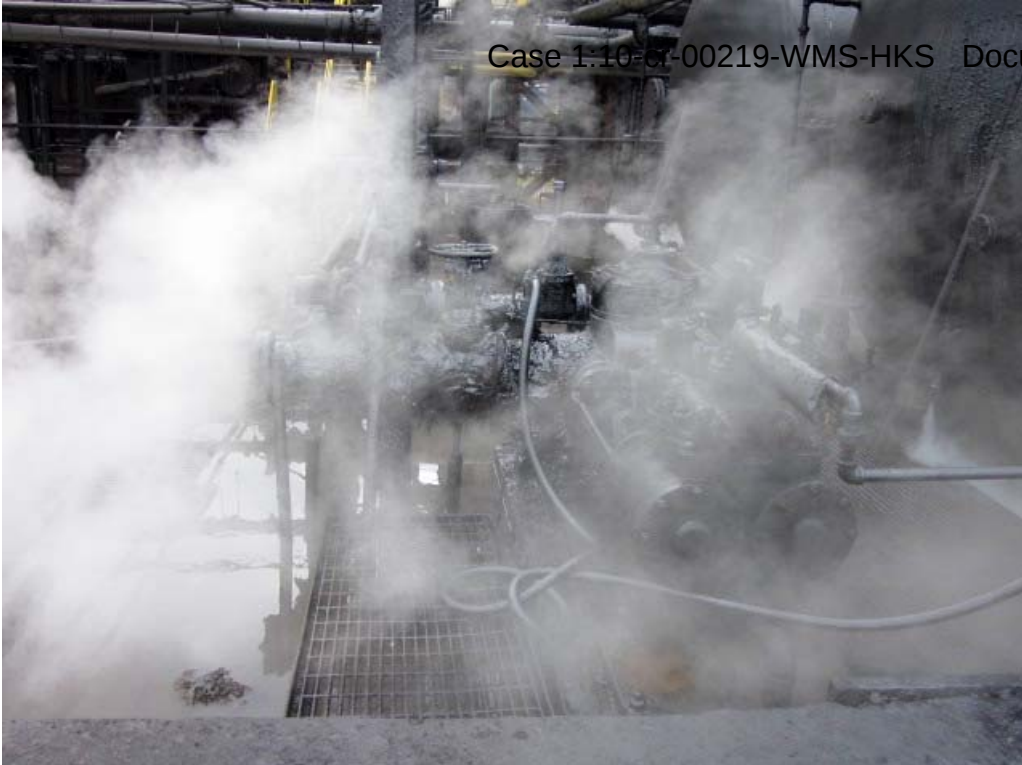
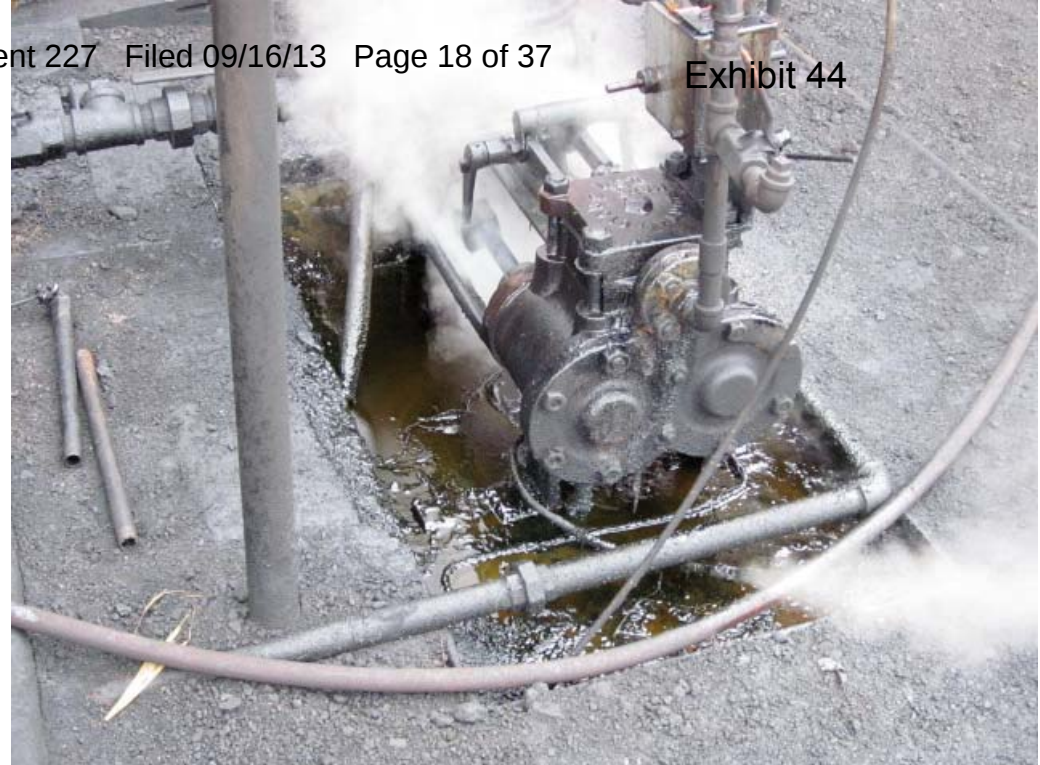
11. General Site Observations: Due to the extensive contamination across the manufacturing area it is difficult to distinguish between the "sheens" given off from the coal tar facilities and those of wanton petroleum releases. As shown in the below referenced photos, there are continuous releases of tar residual from process equipment outside of their respective containment areas. Material within the containment areas reportedly are directed to the facility's wastewater treatment facility and eventually the Town of Tonawanda WWTP. Contaminants that are released outside the containment areas reportedly are discharged with general site storm water runoff to the facility's storm water treatment facility (oil/water separator) and eventually to the Niagara River.

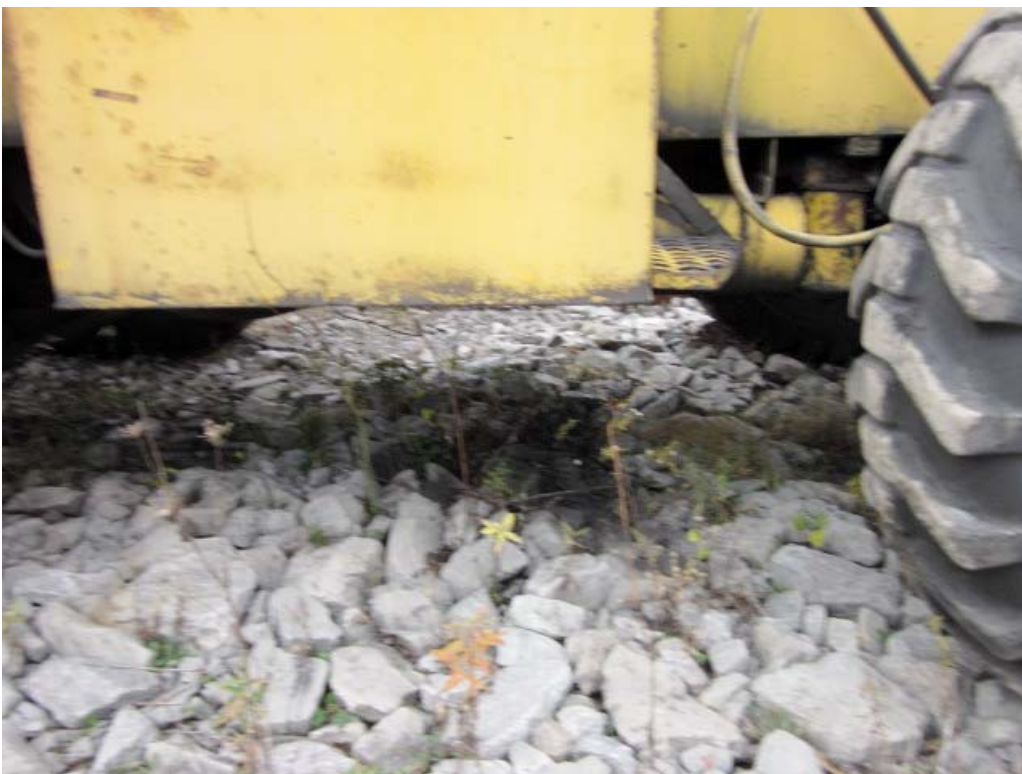
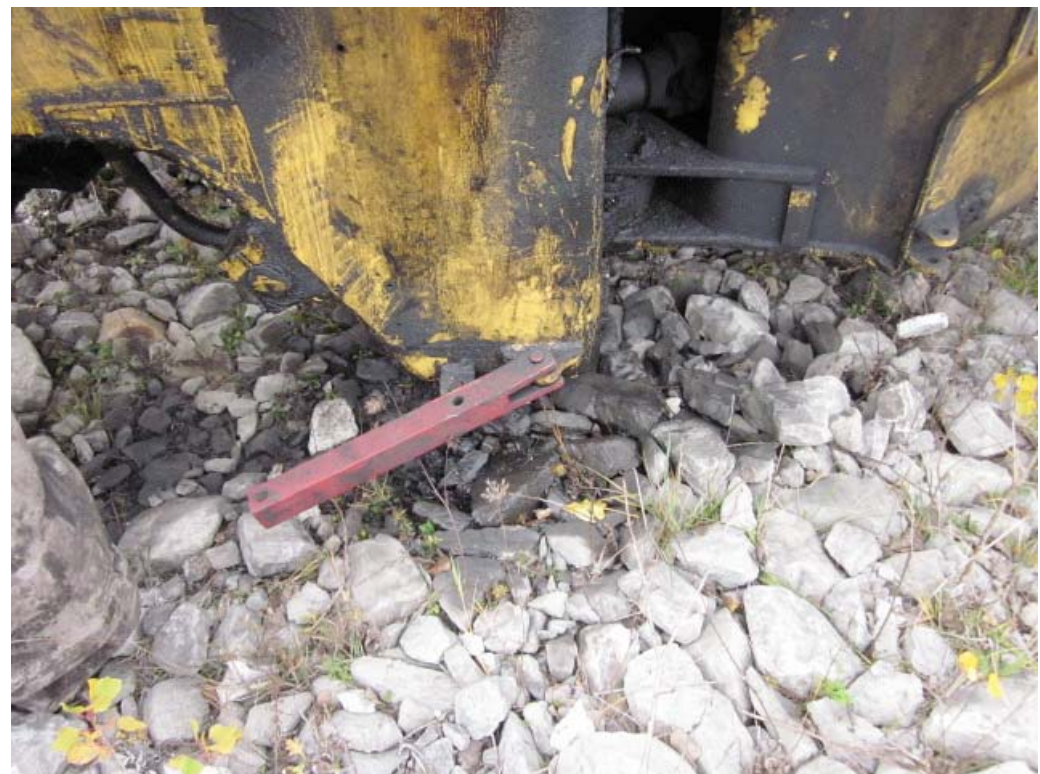
image.sp1207205.2012-11-14.12-LeakingLoaderInBoneYardArea.jpg

area was directly beneath an old loader (image.sp1207205.2012-11-14.12-LeakingLoaderInBoneYardArea.jpg). The loader appeared to be in the process of disassembly and the release may have been from that process or the deteriorated state of the equipment (hoses) it's self (image.sp1207205.2012-11-14.12-LeakingLoaderInBoneYardArea.jpg).

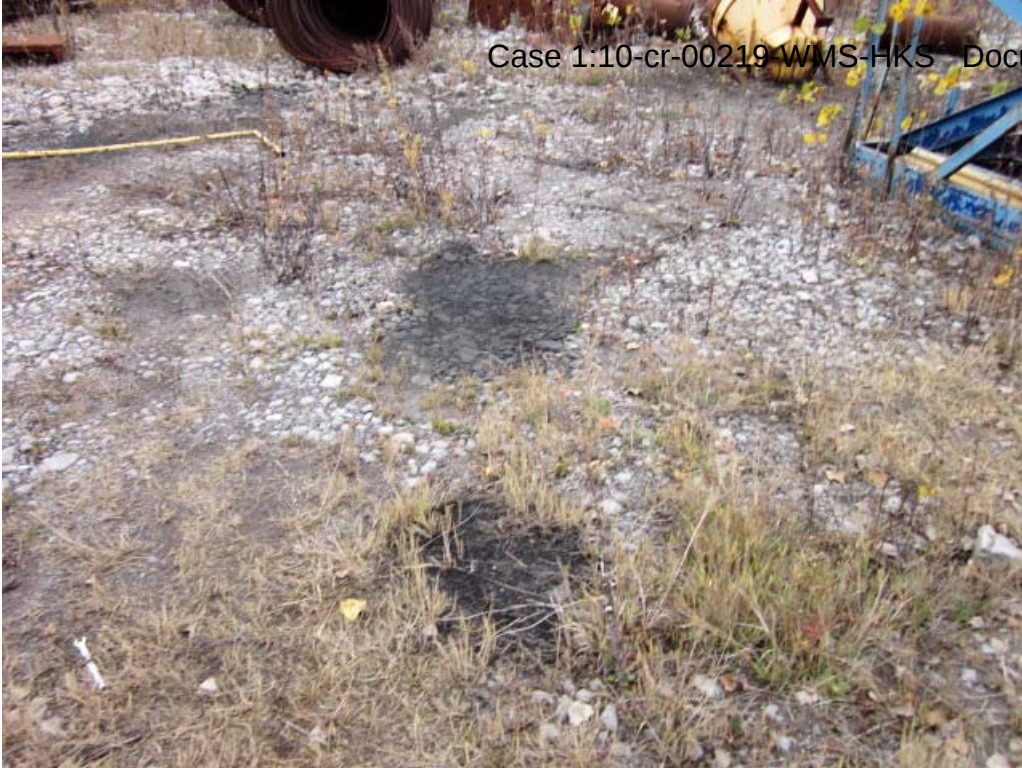
image.sp1207205.2012-11-14.12-OilStainingInBoneYardArea.jpg

Observation: Several small areas of former petroleum releases were noted in this area: two areas were most likely where equipment was once placed and appeared to be older releases (image.sp1207205.2012-11-14.12-OilStainingInBoneYardArea.jpg). Another

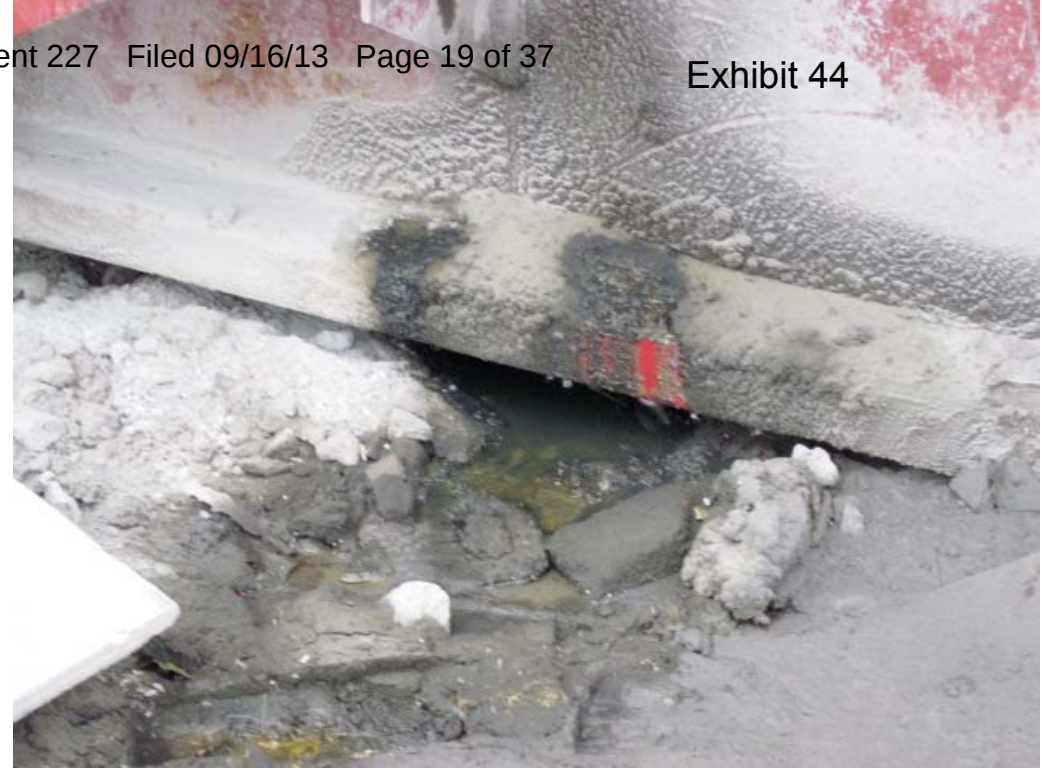
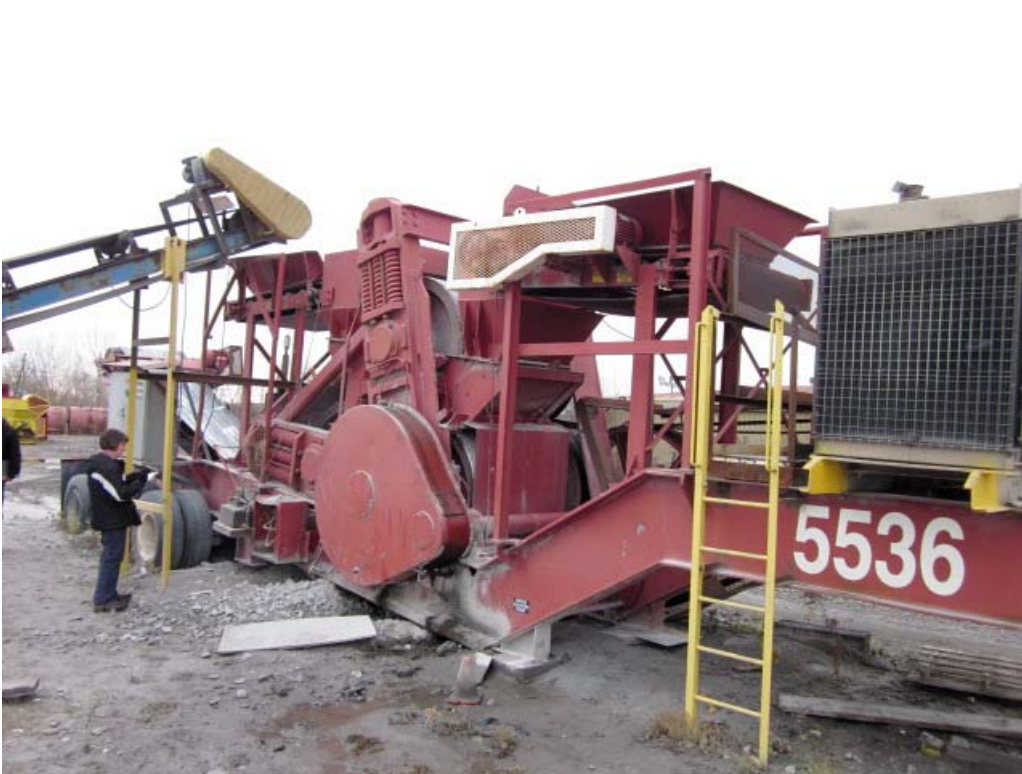
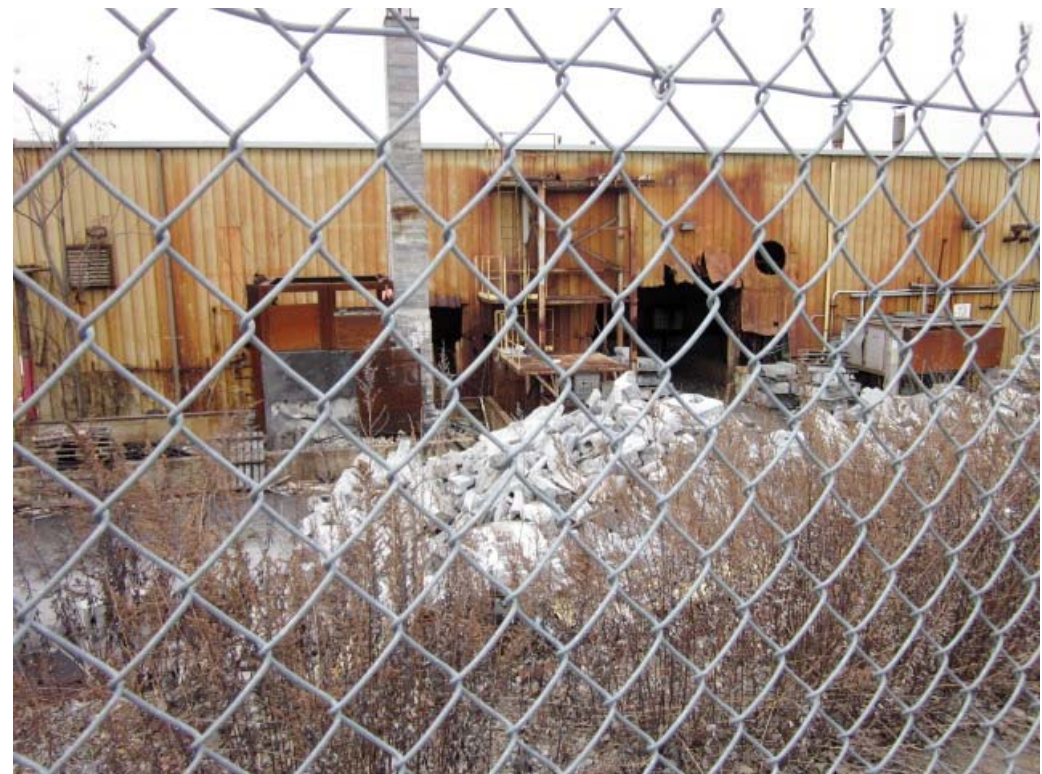
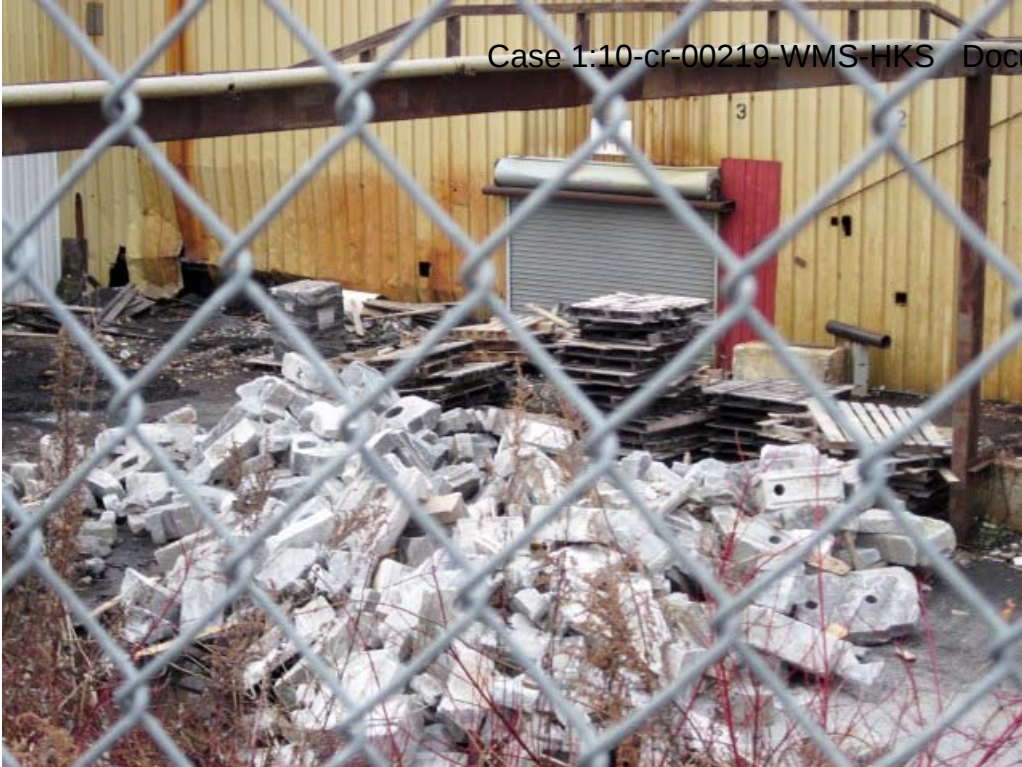
Observation: Discarded refractory material was located in several piles to the rear (east) of the facility with the boundaries of the fenced property (image.sp1207205.2012-11-14.14-WasteCastings1.jpg & image.sp1207205.2012-11-14.14-WasteCastings1.jpg). A portable crusher is located outside the fenced area directly to the east which staff noted is used to crush the material and then recycle the millings back into the manufacturing process (image.sp1207205.2012-11-14.14-VanocurCastingCrusher.jpg) Leaking of either lubricating oil or fuel was noted beneath the crusher's engine area (image.sp1207205.2012-11-14.14-OilDrippingBeneathCrusher.jpg). A small portable diesel tank (100 gal.) was located adjacent to the unit. Division of Air staff participated at the inspection and is evaluating this complaint.

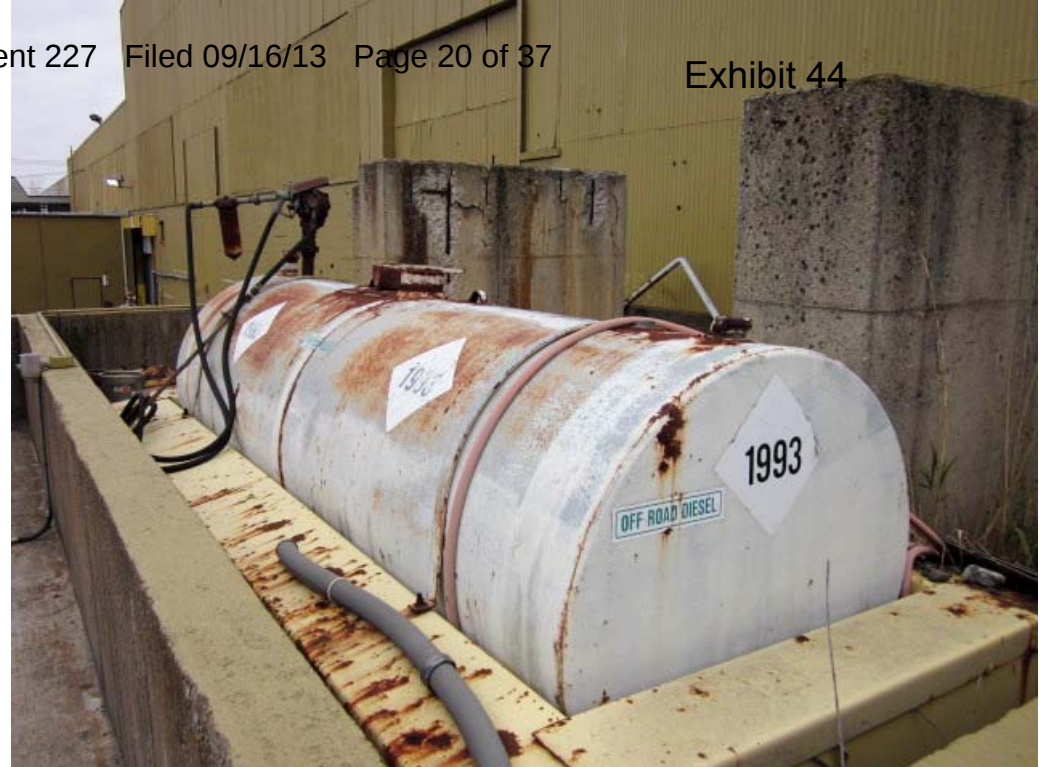
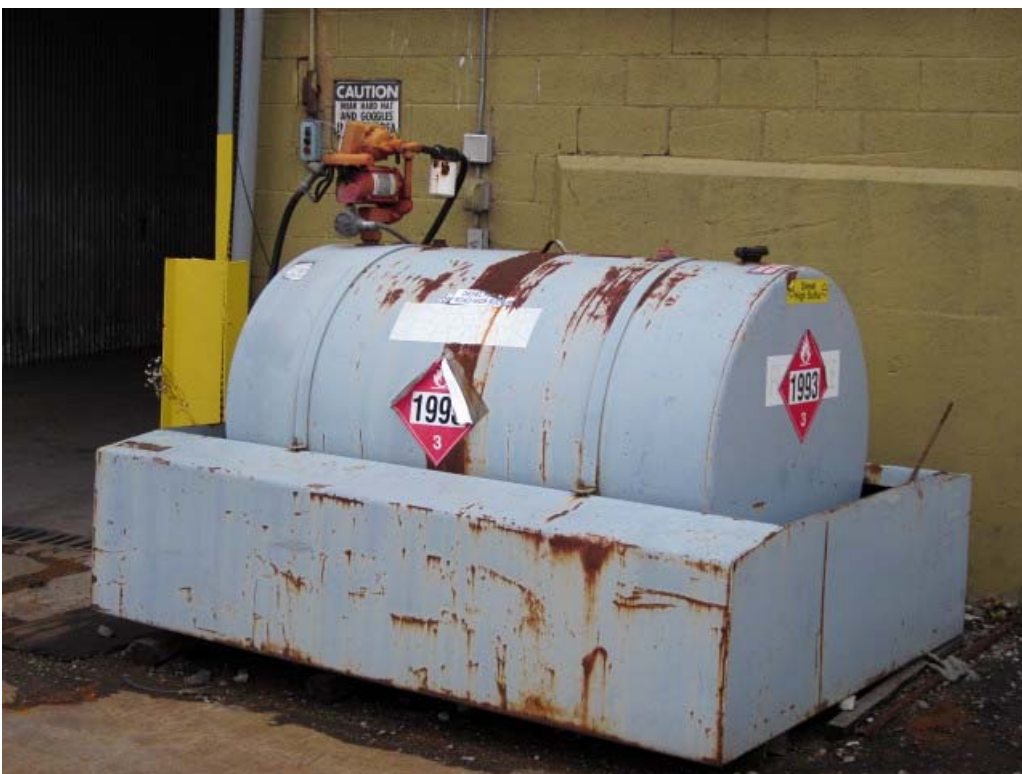
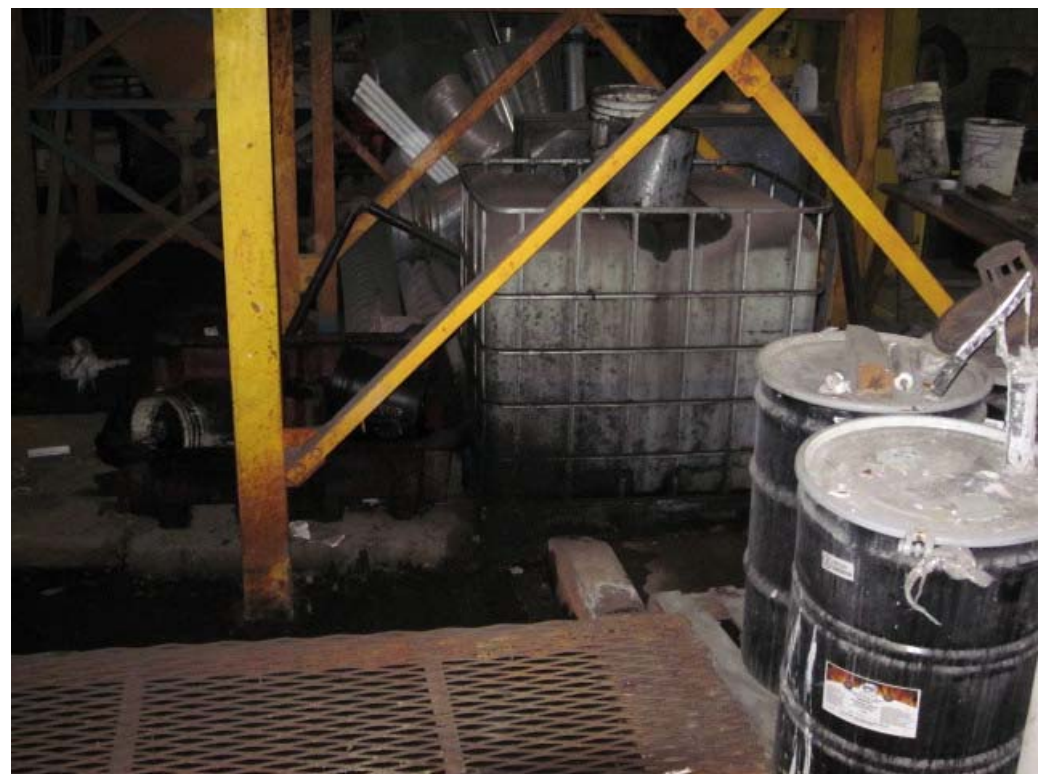
15. General Site Observations: In general, there was little process equipment with the facility that would generate spillage and chemical use also appeared to be minimal with no large vats or process tanks evident. During the brief tour of the facility, however, there appeared to be several drums and totes of unknown materials scattered within the structures that the TCC staff reported to be "left over" from the former IVACO operation (image.sp1207205.2012-11-14.15-Totes-Drums.jpg). In addition the facility maintains several AST (while mostly empty during the inspection) which are used to stored diesel fuel or hydraulic oil. Since the combined capacity of these tanks exceeds 1,100 gals and these tanks are currently not registered with the Department, the facility is in non-compliance with PBS regulations, ie: Part 612 of Title 6 of the New York State Code of Rules and Regulations. (image.sp1207205.2012-11-14.15-500galDieselTank.jpg & image.sp1207205.2012-11-14.15-1000galDieselTank.jpg)

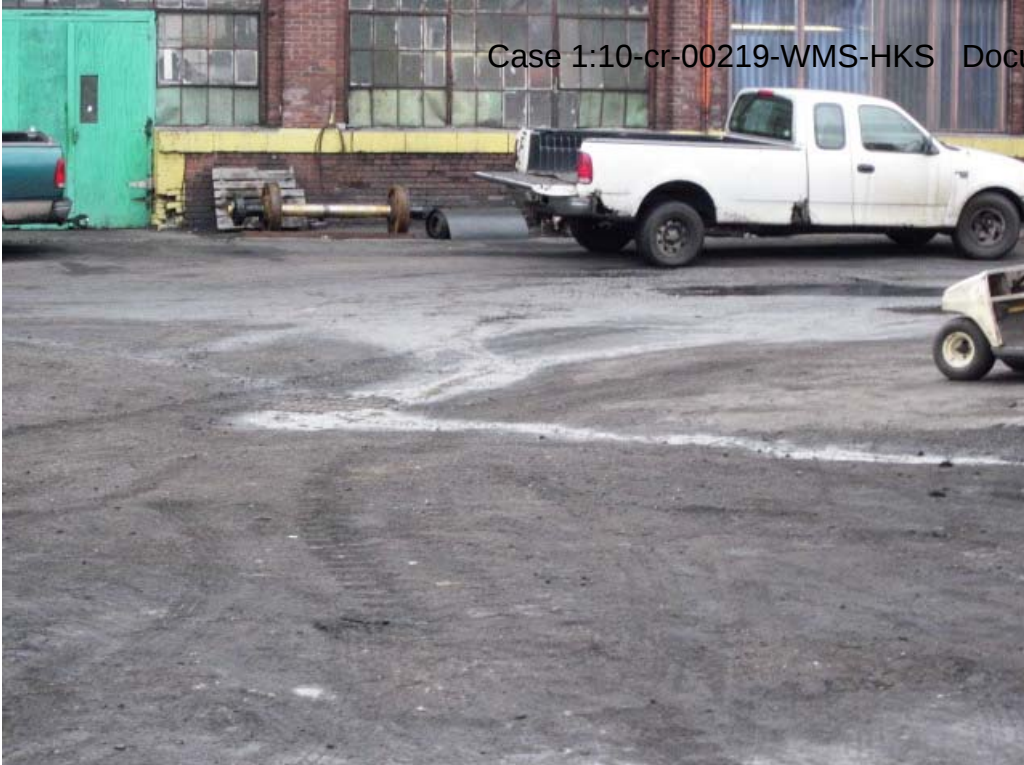
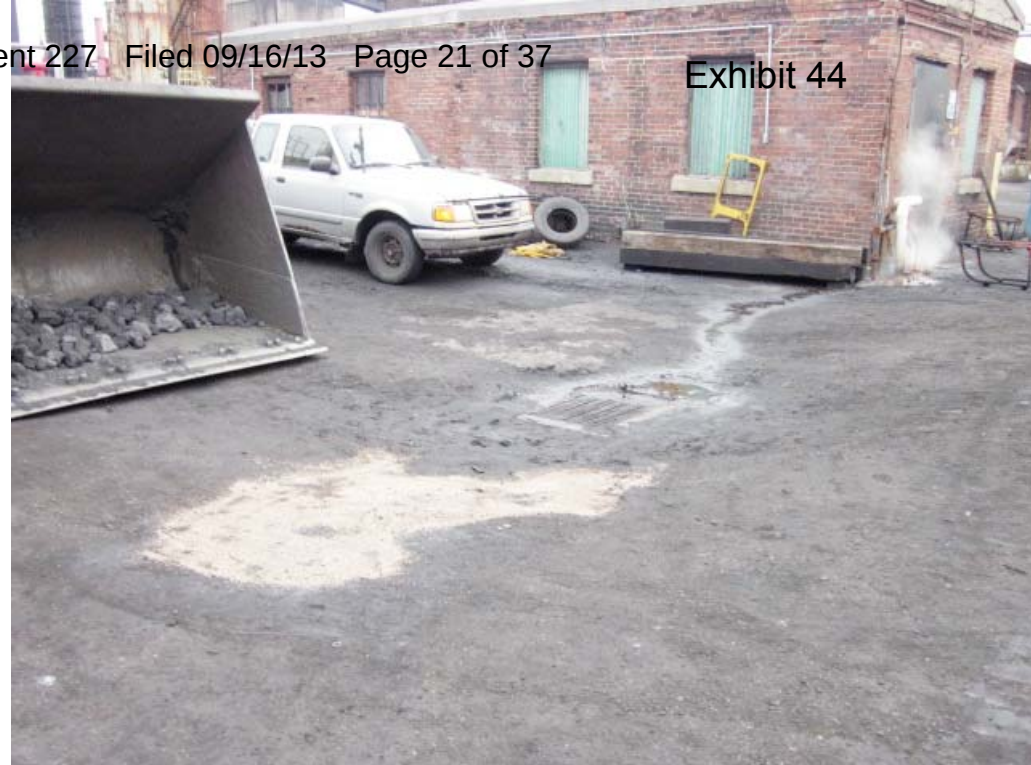
Observation: While the ground in this area consists of the typical black coke/coal fines material, the surface soil also appears to be saturated with petroleum products. Sheens were observed on water draining from the area and the surface material had a physical oil consistency. (image.sp1207205.2012-11-14.2-OilHouseYard.jpg) However, no specific release was observed from the equipment being worked on at the time of the inspection although "speedydry" was spread in an area of the maintenance yard where it is assumed a recent "spill" had occurred. (image.sp1207205.2012-11-14.2-SpeedyDryiOnSpillInOilHouseYard.jpg).

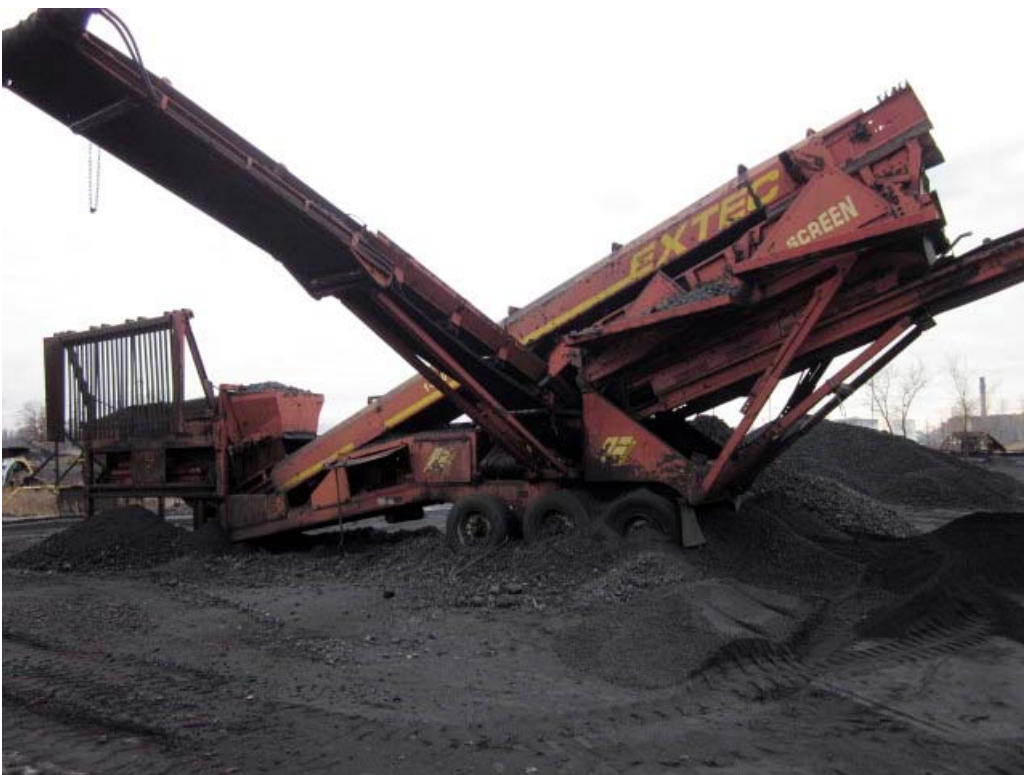
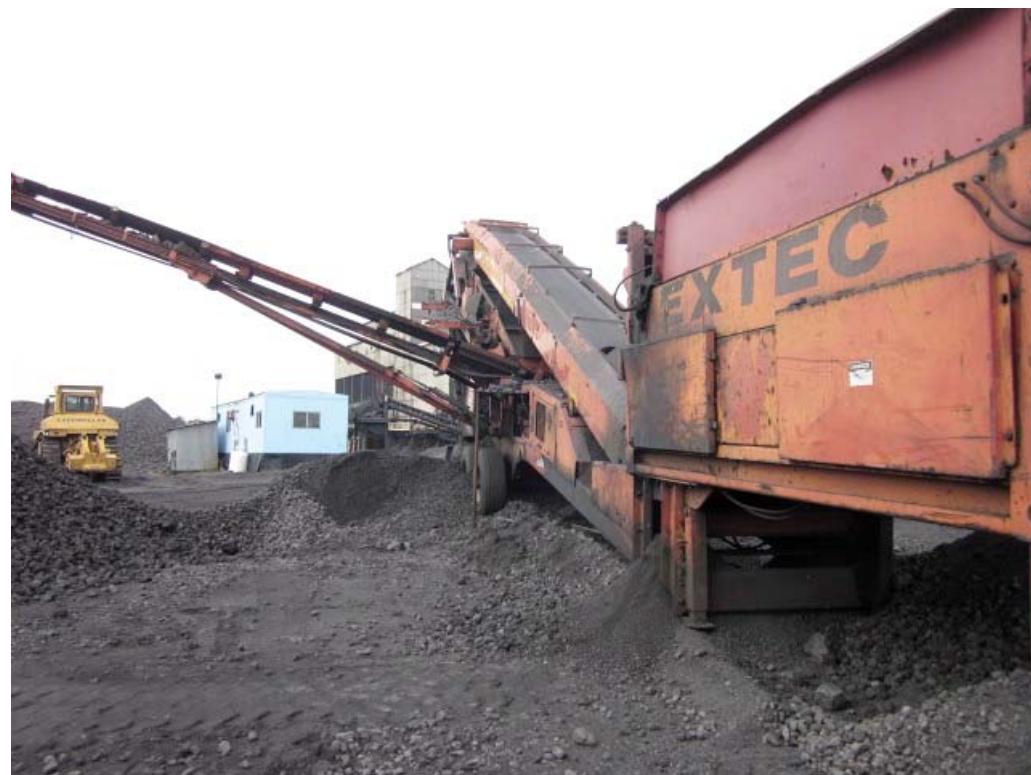
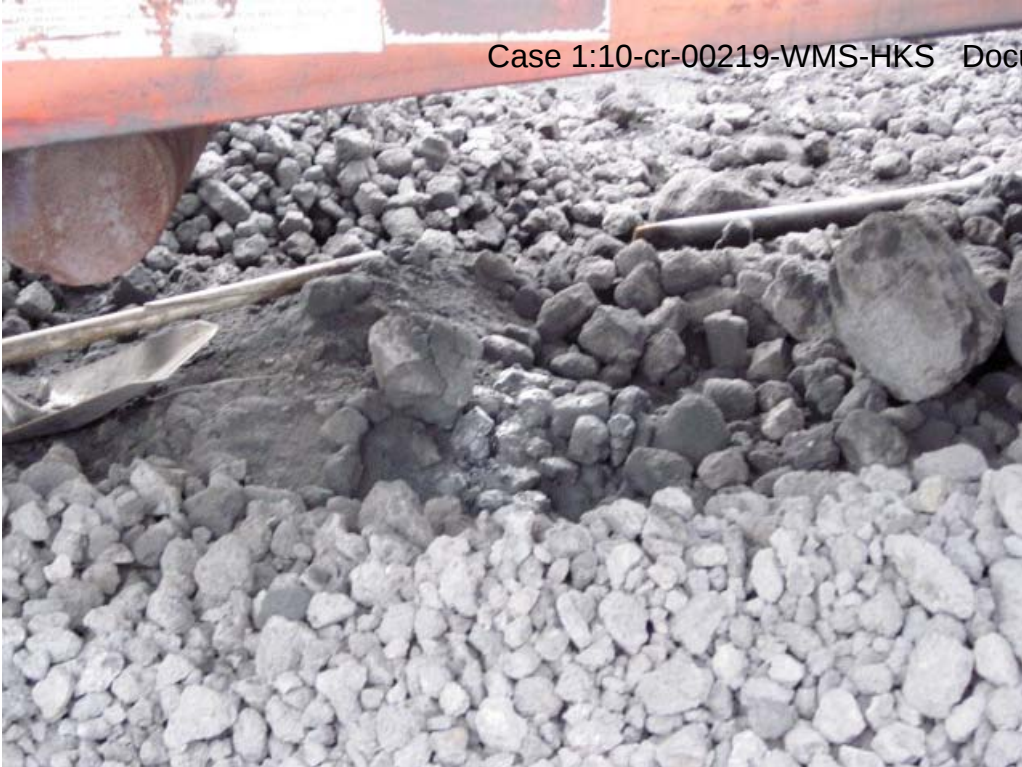
Observation: TCC staff noted that this piece of equipment is portable and is moved around the material handling yard as needed. (image.sp1207205.2012-11-14.3-Extex1.jpg & image.sp1207205.2012-11-14.3-Extex2.jpg) During the inspection, the unit was in operation and a constant leak from the motor assembly was observed. (image.sp1207205.2012-11-14.3-ExtexMotorLeak.jpg) Coal fines were piled around the unit making the observation of past releases very difficult to detect. No other releases were observed from the unit during the inspection. Note the western (03) area where the Extex was formerly located could not be inspected because it is currently covered with a
